REHABILITATION OF NAVIGATION LOCK WALLS: CASE HISTORIES

James E. McDonald

Structural Laboratory

December 1987

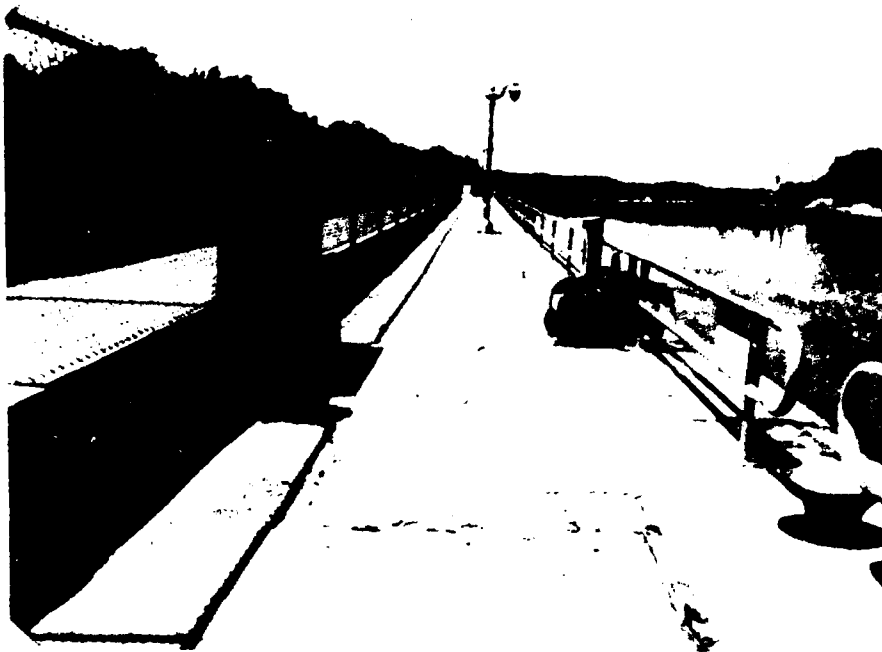
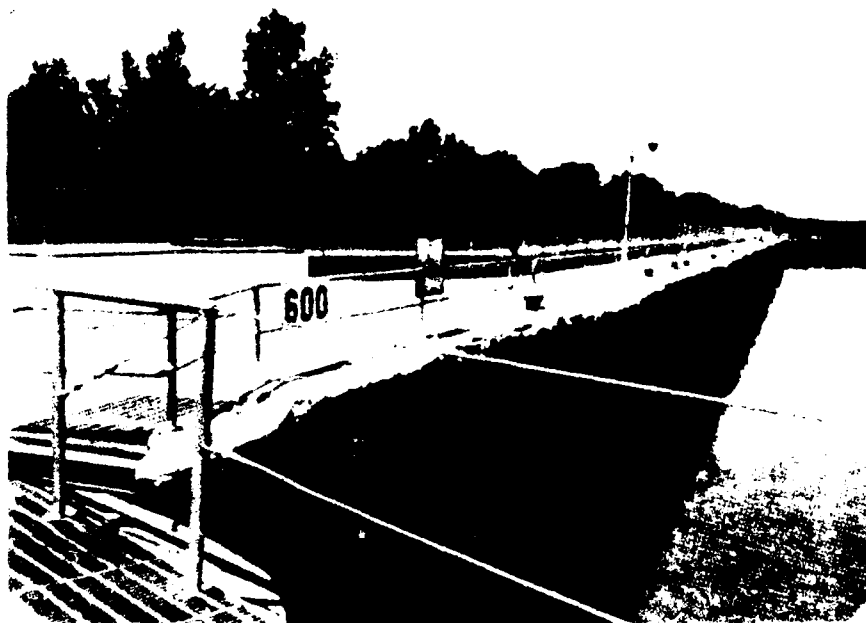
Figure 6. Typical concrete deterioration, 1962, Marseilles Lock

26. After almost 30 years exposure to severe weathering, horizontal concrete surfaces had scaled to an average depth of 3/4 in. Similar conditions existed on vertical surfaces, particularly at the joints. In addition, abrasion by vessels and ice had chipped concrete surfaces, particularly at upper and lower pool elevations and at the top of the wall (Figure 6). As a result, it was proposed to resurface portions of the top surface of the lock walls (Chicago District 1963). Also, portions of the vertical surfaces near the top of the walls were to be resurfaced and corner armor installed (Figure 7). This work was completed in 1965 at a cost of \$80,000.

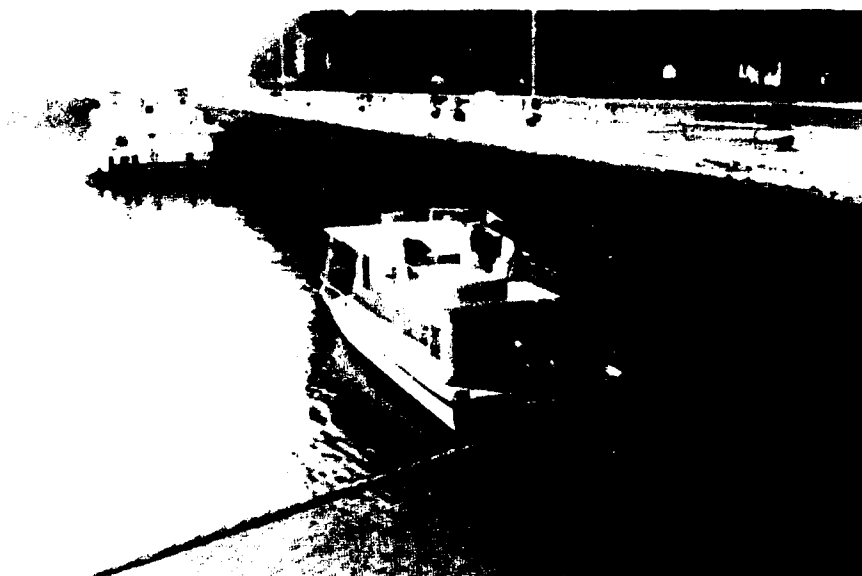
Figure 8. Severe deterioration of north lock wall, 1972, Marseilles Lock

28. The second periodic inspection was conducted in August 1972. Concrete resurfacing on top of the north lock chamber wall was in good condition; however vertical surfaces were severely deteriorated, particularly at monolith joints (Figure 8). Similar conditions existed on the south wall with the addition of a few minor cracks on top of the wall. The chamber walls had eroded to the point that the downstream miter gate was vulnerable to barge

traffic when the gate was in the open position. It was concluded that if allowed to progress, loss of section through erosion would impair the stability and integrity of the lock walls. Therefore, it was recommended that the lock chamber walls be resurfaced. Since such a repair would have to be accomplished with a minimum of lock downtime, the Office of Chief of Engineers (OCE) suggested that precast concrete stay-in-place forms be studied as a potential repair technique. The Little Rock District (1963) had investigated this system of forming for new construction, and the Bureau of Reclamation had used it in the restoration of Barker Dam (Davis 1948).

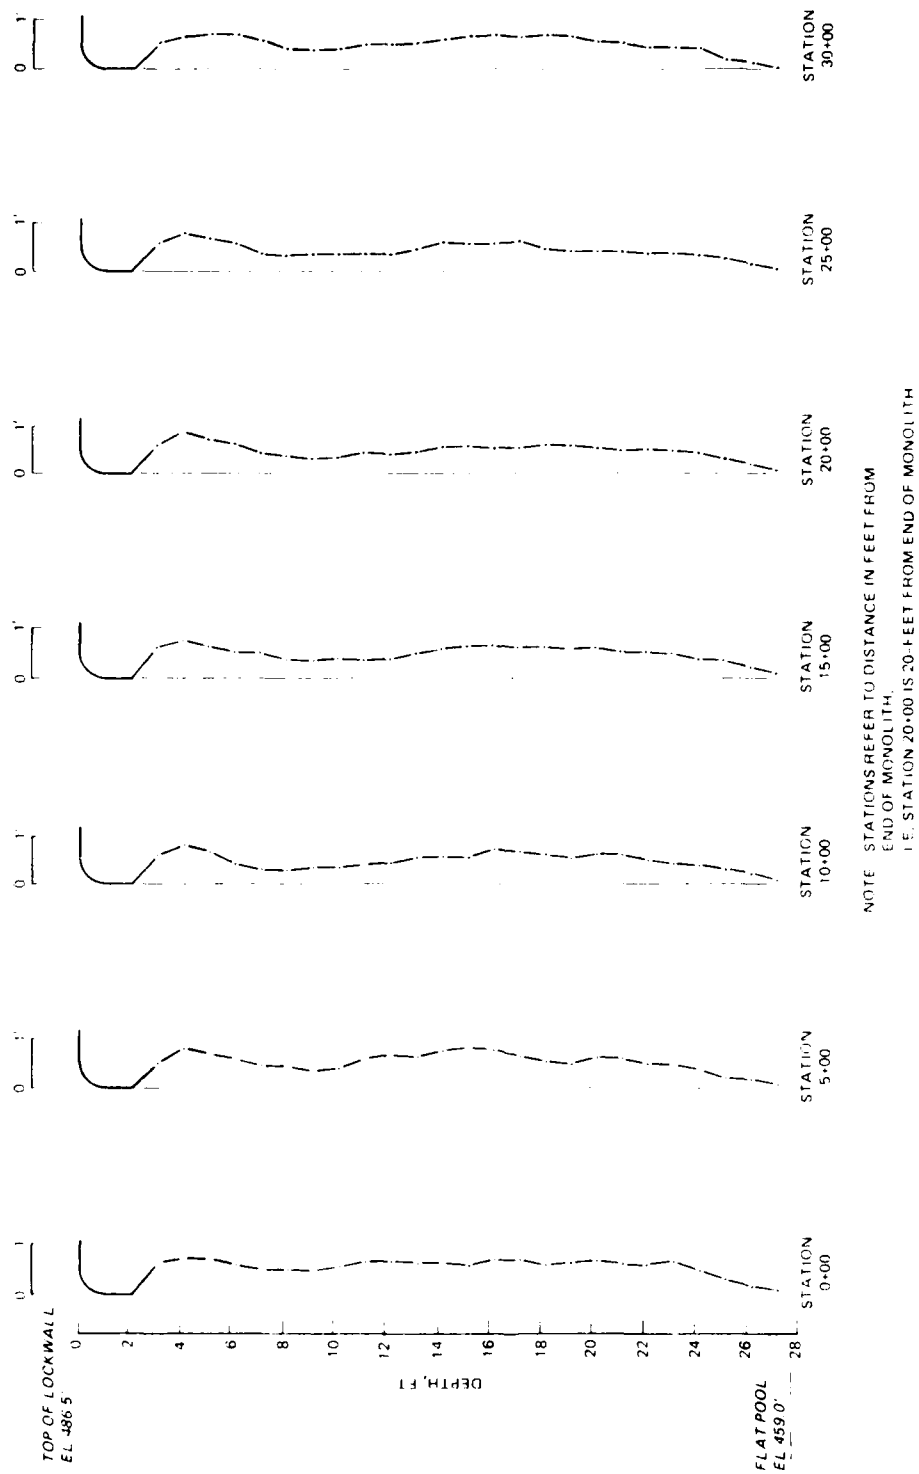
Figure 10. Cross section of monolith 31, 1973, Marseilles Lock

29. In 1973, the depth of concrete erosion was established through a detailed survey of the vertical surfaces of the lock chamber walls. In the survey, erosion depths were measured at 5-ft intervals horizontally and vertically. Generally, the depth of erosion ranged from 0.20 to 0.65 ft, with an overall average of about 0.40 ft of concrete eroded from the original surface.

The maximum depth of erosion (1.10 ft) was measured in a few isolated areas. The surface of a typical monolith (31) is shown in Figure 9, and the results of the survey on the monolith are shown in Figure 10. Erosion of the concrete ranged from slightly above low pool elevation to approximately 2 ft below the top of the wall with the most severe erosion in the upper portion of the walls.

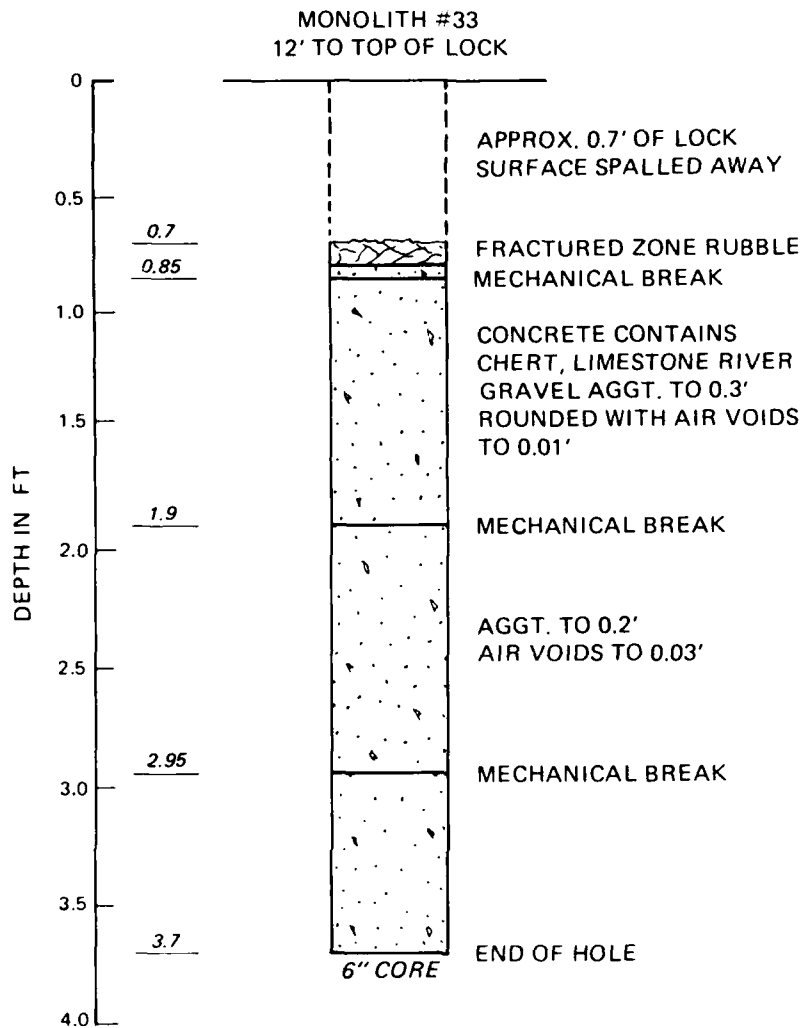
Figure 11. Typical concrete core log, 1974,
Marseilles Lock

30. A program to assess the quality of the remaining concrete and to establish the depth of deteriorated concrete was also conducted. Six horizontal concrete cores, 6-in. diameter by about 3 ft long, were obtained from each wall and tested at the Ohio River Division Laboratory (Chicago District 1974). A typical log of the concrete core is shown in Figure 11. Specimens for compressive strength tests were taken from those portions of the cores located a minimum of 0.7 ft behind the existing face of the wall. Compressive strengths ranged from 5,070 to 7,760 psi with the average of nine tests being 6,440 psi. No increase in strength was noted with increasing depth; in fact, the deeper test specimens generally exhibited lower compressive strengths. Depth of fracturing in the concrete, as determined by petrographic examination, ranged from 0.1 to 1.1 ft with an average depth of 0.5 ft. Other observations based on the petrographic examination are summarized in the following:

- d. The depth of iron-staining appeared to be the depth of penetration of water from the lock chamber. This surface was very irregular and always deeper than the depth of deterioration of the concrete.

- e. The series of fractures parallel to the lock wall surface which were present in the top portion of each boring appeared to be due to freeze-thaw action.

- f. The percent of air voids in the specimens ranged from 0.72 to 2.12.
- g. The air voids were due to entrapped air and were generally associated with the porous dolomite particles.

- h. The concrete contained no entrained air.

- i. The depth of deterioration appeared to be greater between elevations 482.7 and 471.5 (average of 1.08 ft) than between elevations 471.5 and 465.0 (average of 0.76 ft).
- j. The core from all borings was tested with the Schmidt Impact Hammer. The results were inconclusive due to the inconsistency and variability of the readings.

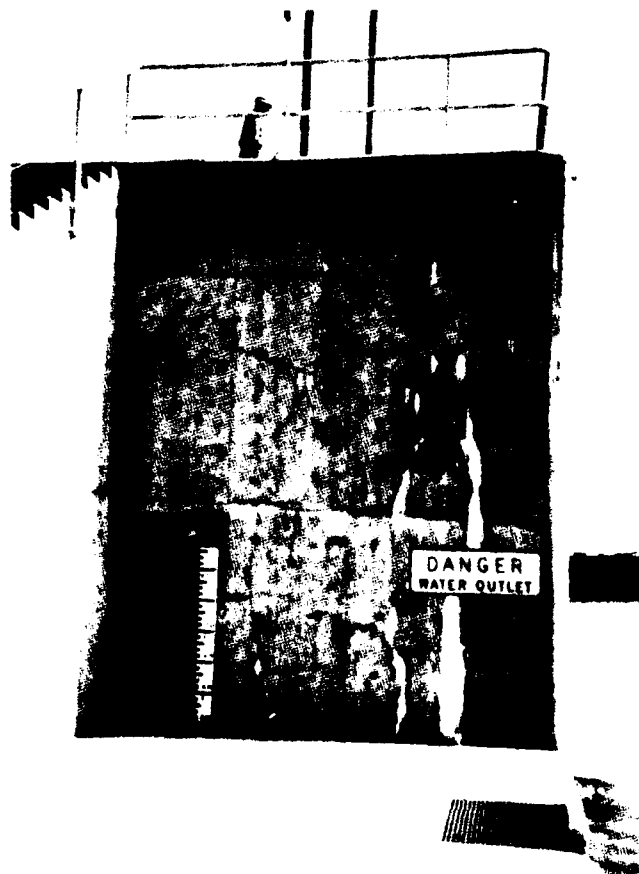
- (1) The top surface of the concrete in the upper right emergency gate bay monolith is moderately scaled. The upstream right gate monolith has reflective cracks that are typical of all resurfaced gate monoliths. There are weeds growing out of the monolith joint next to the downstream right service gate.
- (2) The sidewalk adjacent to the right lock wall monoliths has subsided. According to the lockmaster, Walt Gatza, the problem began with dewatering of the lock chamber for rehabilitation work. Mud jacking was undertaken in 1978 to raise the slabs, but the problem remains.
- (3) The lock chamber walls are generally in good condition, although there is some minor cracking and occasional epoxy spalled out on the top edges.
- (4) The downstream vertical faces of monoliths 55 and 56, resurfaced in 1978, have large shrinkage cracks and some leaching (Figure 16).

Figure 16. Cracking in downstream face of monolith 55, September 1982, Marseilles Lock

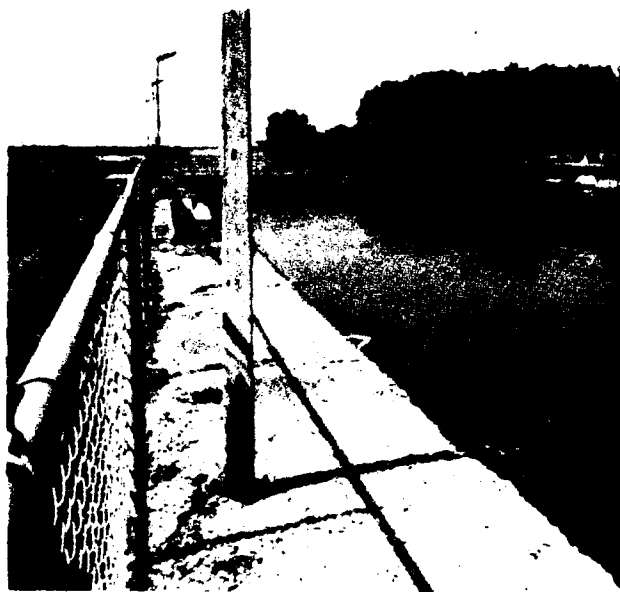
Figure 18. Typical concrete deterioration,
1977, Old Lock No. 14, Mississippi River

- c. The concrete in the top of the riverside wall was deteriorated to a depth of about 10 in. The 6-in. concrete cap on the landside wall was in good condition; however the concrete beneath the cap was deteriorated to a depth of about 12 in. The downstream gate monolith on the riverside wall exhibited a similar condition (Figure 19). The depth of deterioration on vertical surfaces ranged from 2 to 7 in.

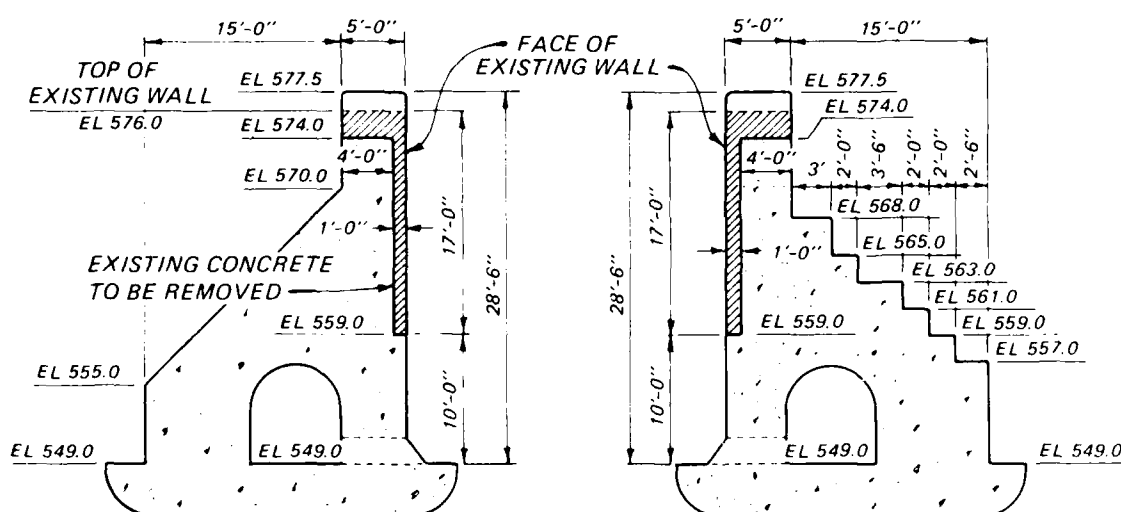
Figure 21. Typical sections showing extent of concrete removal and replacement, Old Lock No. 14, Mississippi River

51. Concrete deterioration on vertical surfaces was generally confined to those areas of the lock walls above low water level (Figure 20). Therefore, concrete removal and replacement was confined to the top 17 ft of the walls except for the outer gate monoliths where extensive concrete removal was necessary to accommodate new gates and operating machinery (Rock Island District 1980). Twelve inches of concrete was removed from the vertical face of the walls, and two feet of concrete was removed from the top of the walls (Figure 21).

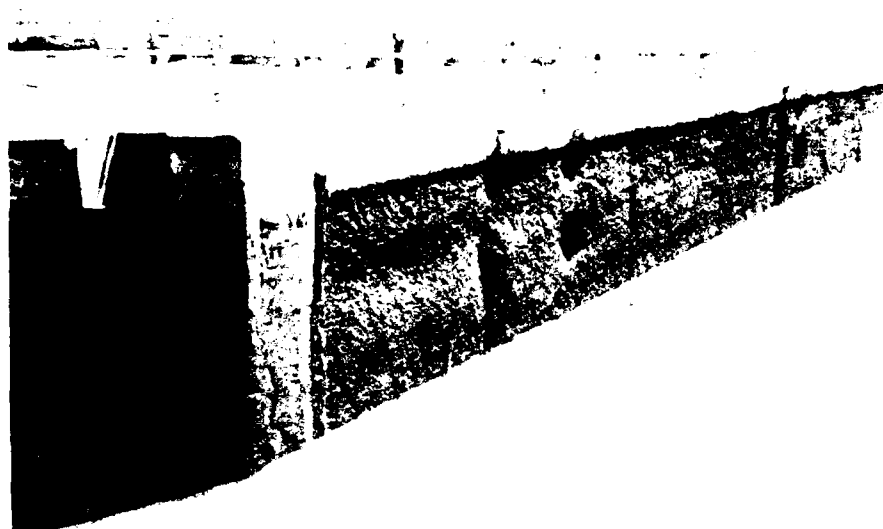
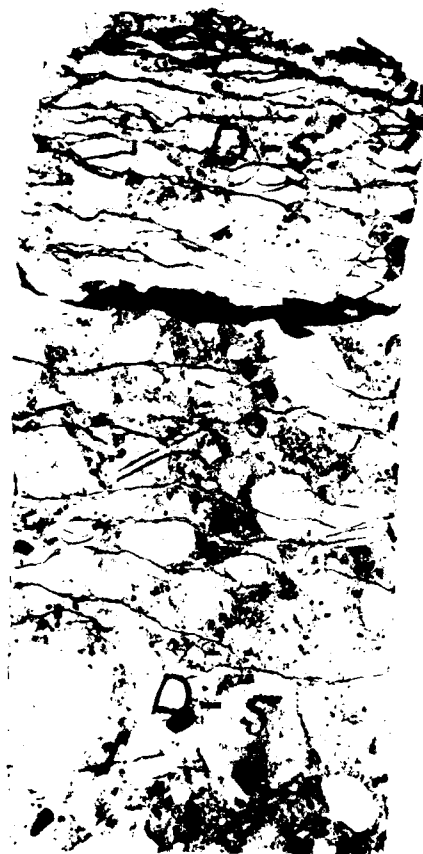
72. Deterioration of the exposed and near surface original concrete ranged from light to severe. About 80 percent of the exposed vertical surfaces of the concrete in the lock walls had been effected by frost action (Figure 31). The average depth of concrete deterioration as determined by petrographic examination were as follows: lock chamber walls, 0.7 ft; river-side of river wall, 0.9 ft; and the upper gate bays, 1.5 ft. Severe loss of concrete was evident at most monolith joints.

Figure 31. Typical concrete deterioration, 1977,
Dresden Island Lock

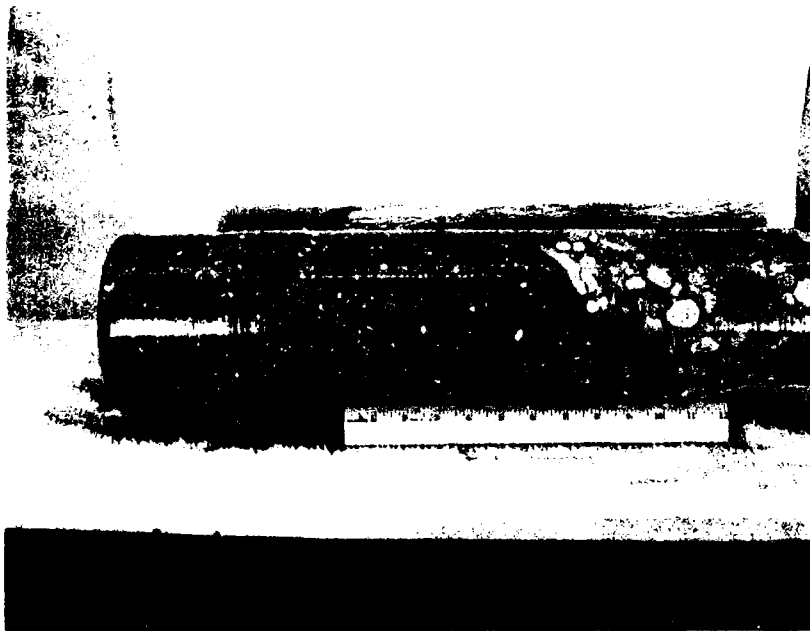
73. Three borings were drilled from inside the lock chamber into the river wall section previously refaced with shotcrete. The shotcrete had a minimum thickness of 12 in. (Figure 32) and exhibited excellent bond to the original concrete. Air-void data determined according to CRD-C 42 indicated the shotcrete had about 3 percent total air with approximately 2 percent of it in voids small enough to be classified as useful for frost resistance. The air-void spacing factors ranged from 0.010 to 0.014 in. While these values are larger than is desirable (0.008 in. is considered the maximum value for air-entrained concrete), they may have imparted some frost resistance. Also, there were no large voids or strings of voids due to lack of consolidation such as have been observed with other shotcrete specimens. Typical surface conditions of the shotcrete are shown in Figure 33.

Figure 32. Horizontal core taken through shotcrete resurfacing, 1976, Dresden Island Lock

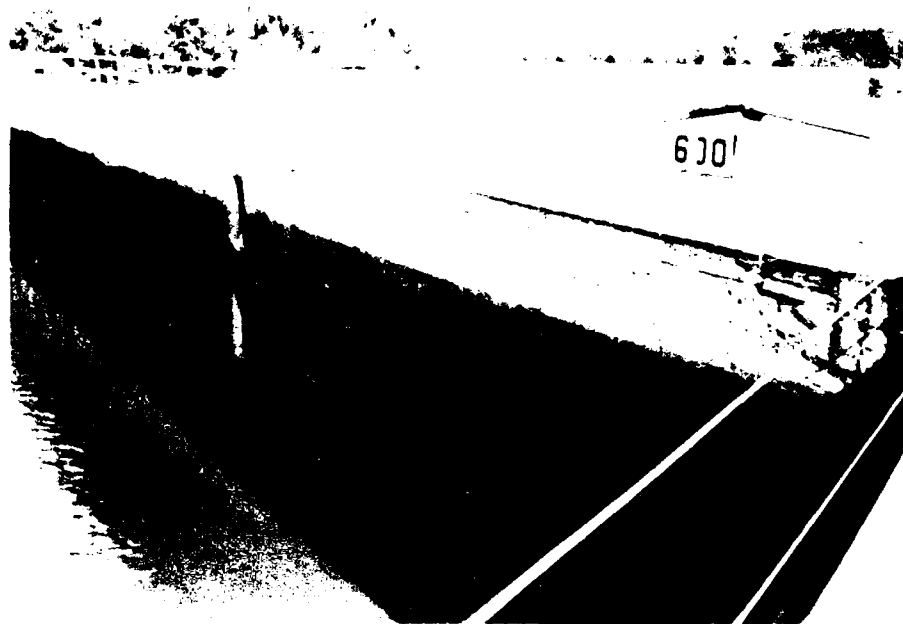
a. River wall

b. Interface between shotcrete (left)
and original concrete

Figure 33. Shotcrete surface conditions, 1977,
Dresden Island Lock

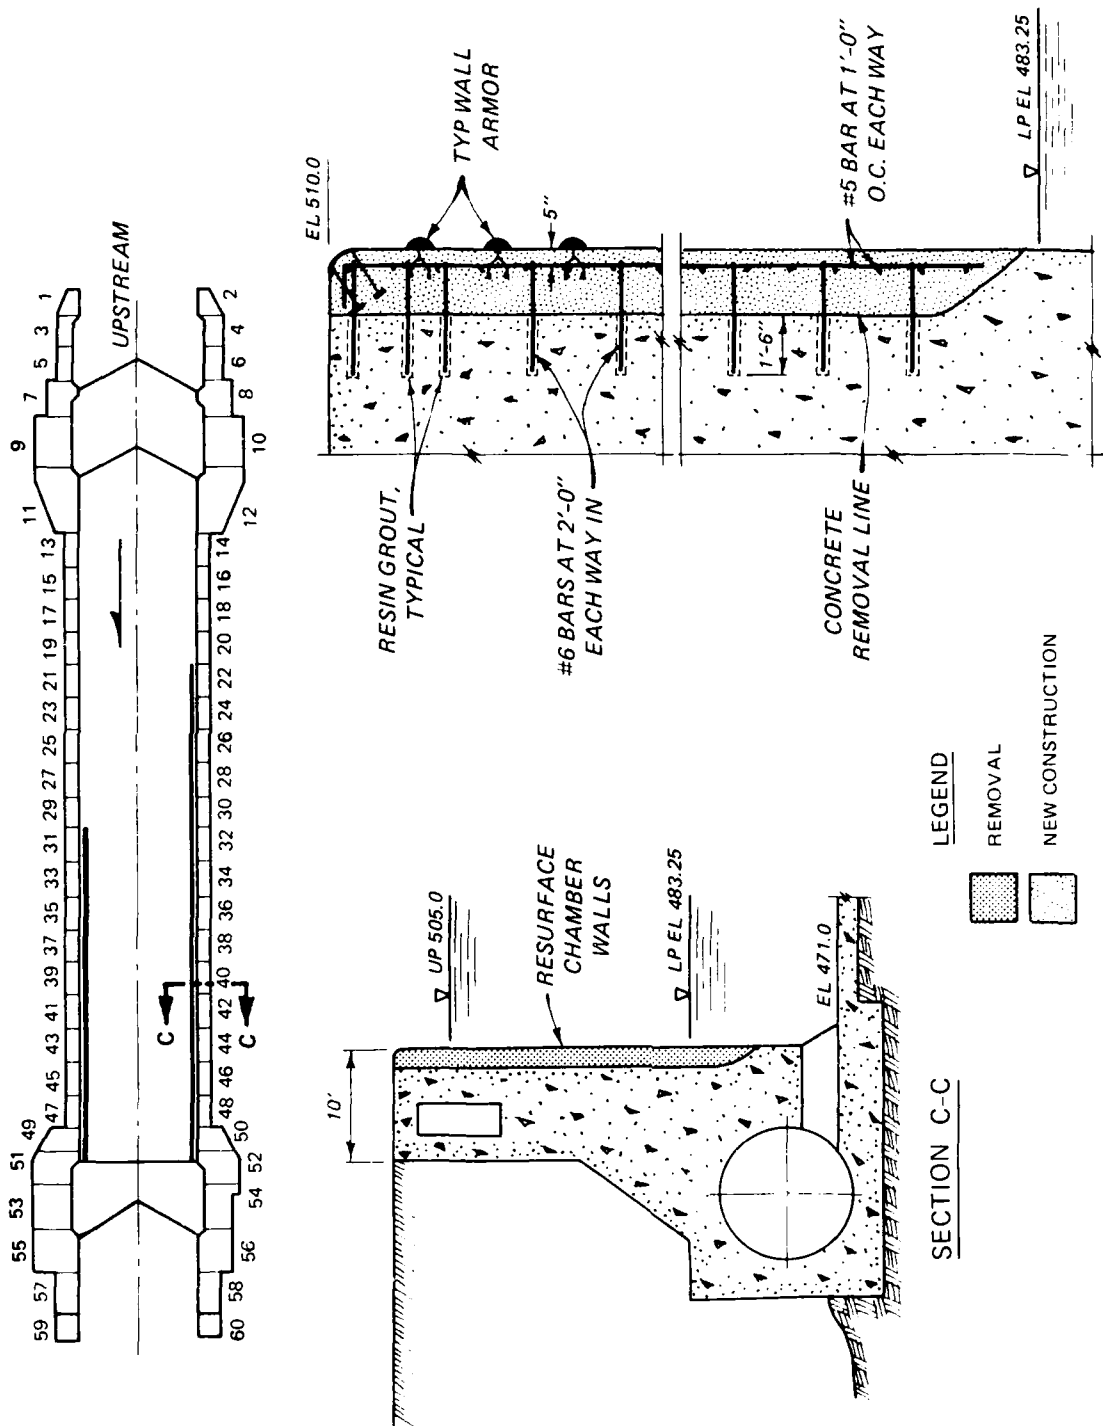
Figure 37. Land wall resurfacing, Dresden Island Lock

79. Following removal of concrete to a depth of 17 in. from the original wall surface, the lock walls were resurfaced as shown in Figures 37 and 38. Concrete anchors were No. 6 reinforcing bars spaced on 2-ft centers each way. The anchors were embedded using two-component polyester resin grout cartridges. Insertion of the anchor into the drill hole ruptured the seal between the two-component resin in the previously installed cartridge. Mixing of the grout was accomplished by spinning the anchor using an electric drill. A straight anchor bar was selected for ease in attachment to the drill chuck. The size, length of embedment, and spacing of the anchors were arbitrarily selected using engineering judgment. To assure adequate embedment of the anchors, pull-out tests were specified. Three anchors were specified to be

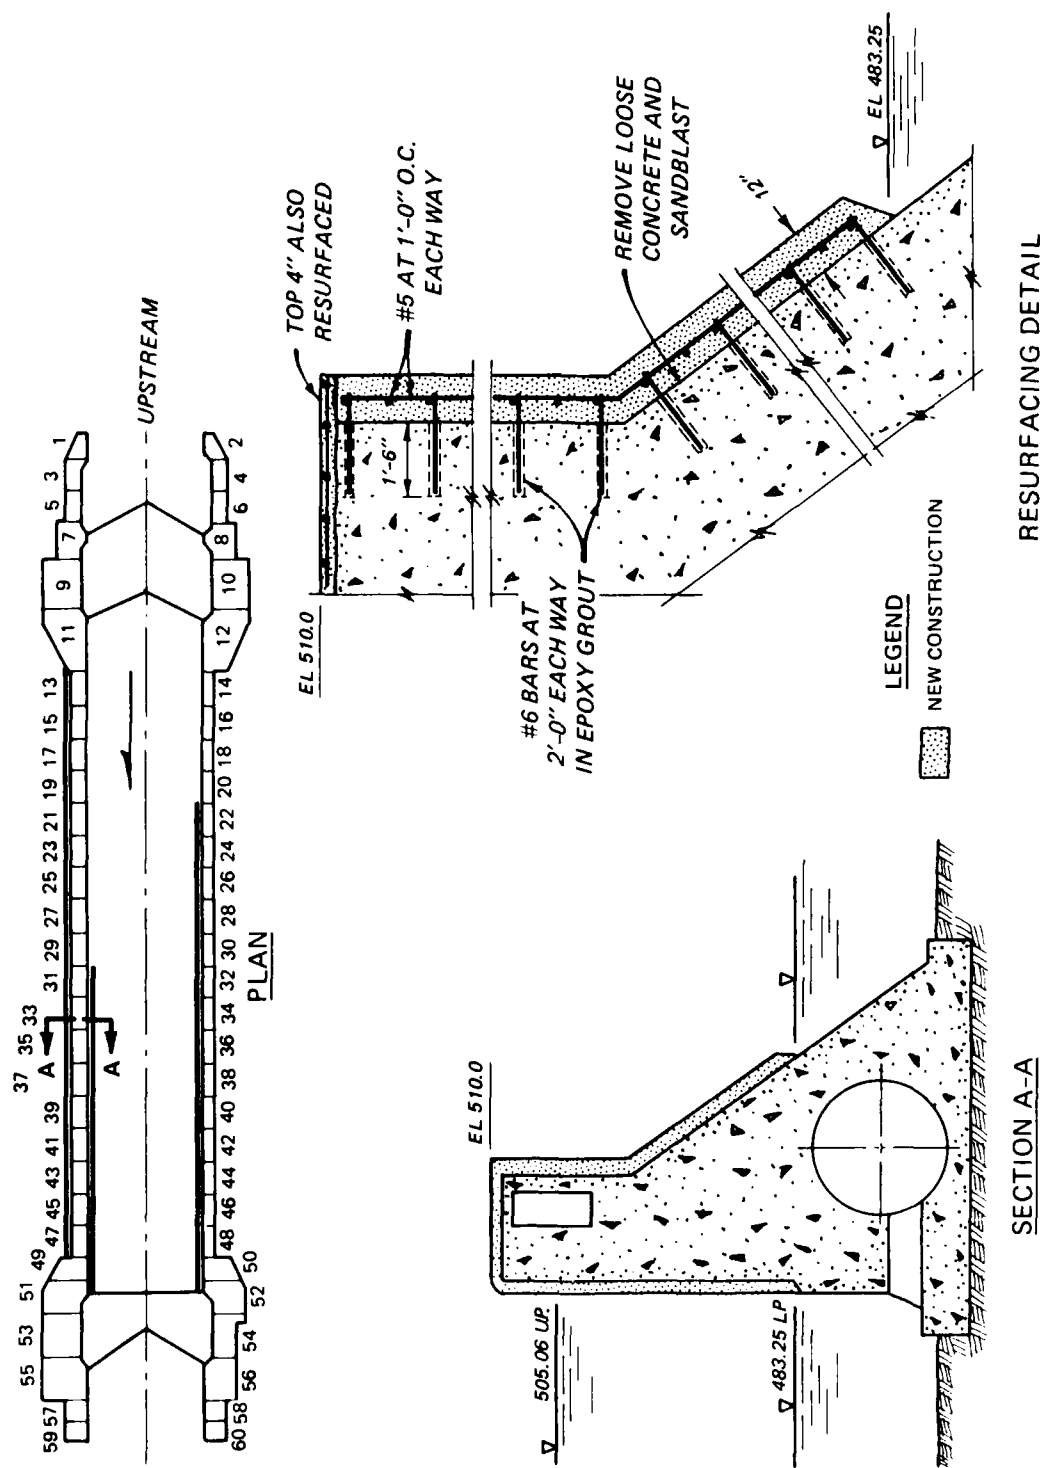
Figure 38. River wall resurfacing, Dresden Island Lock

83. The 12-in. thick concrete overlay on the backside of the river wall was placed over the existing weathered concrete (Figure 38). The new concrete was intended to serve as a sealer and to protect the concrete below from further disintegration. The existing weathered concrete was not removed for reasons of economy. It was believed that with anchored concrete, where structural and user considerations permit, this method may be the optimum repair

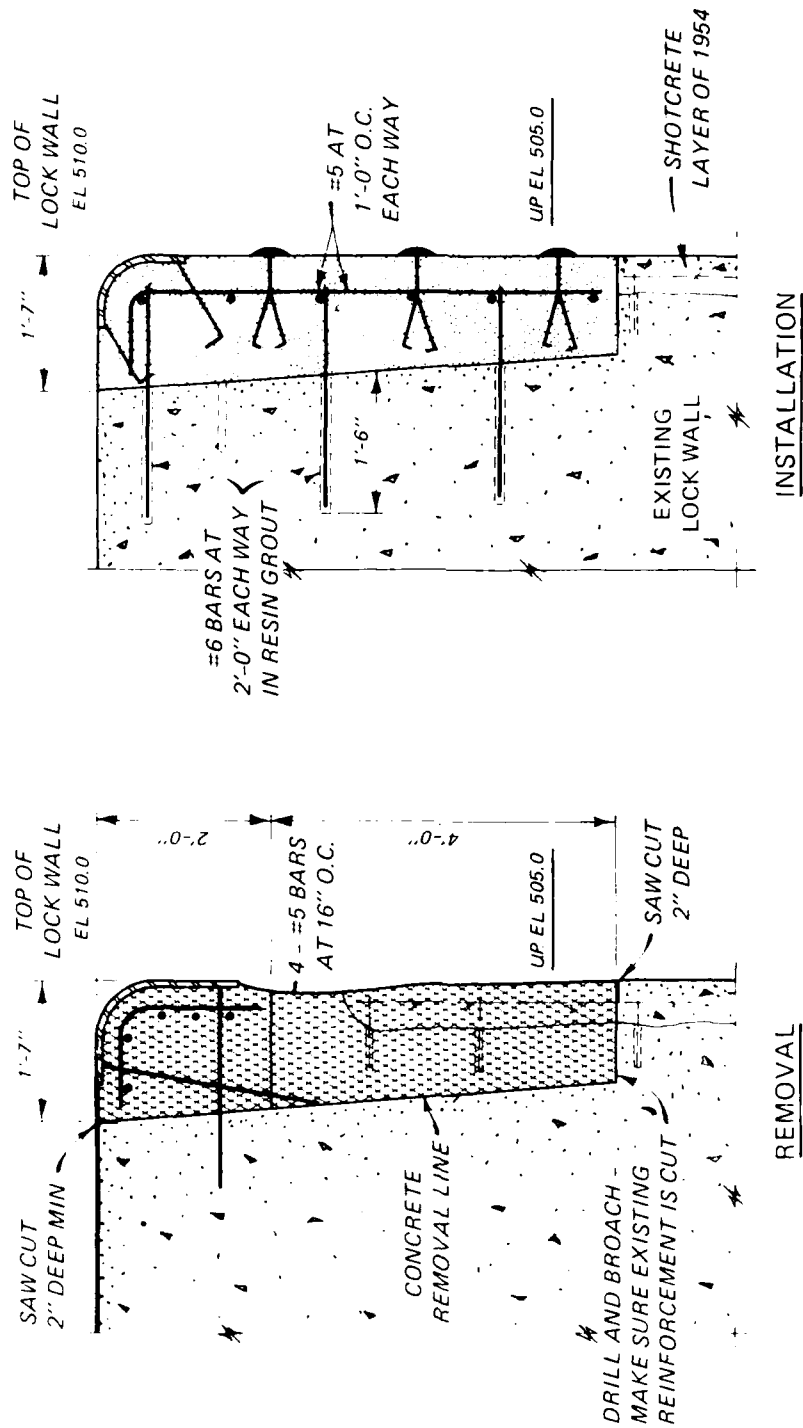
Figure 39. Armor installation in portions of lock wall previously resurfaced with shotcrete, Dresden Island Lock

82. Wall armor was installed in that portion of the lock walls previously repaired by shotcreting as shown in Figure 39. Note that at the bottom removal line drilling and broaching was specified to prevent cracking in the concrete below. Similar armor was installed in the concrete resurfacing.

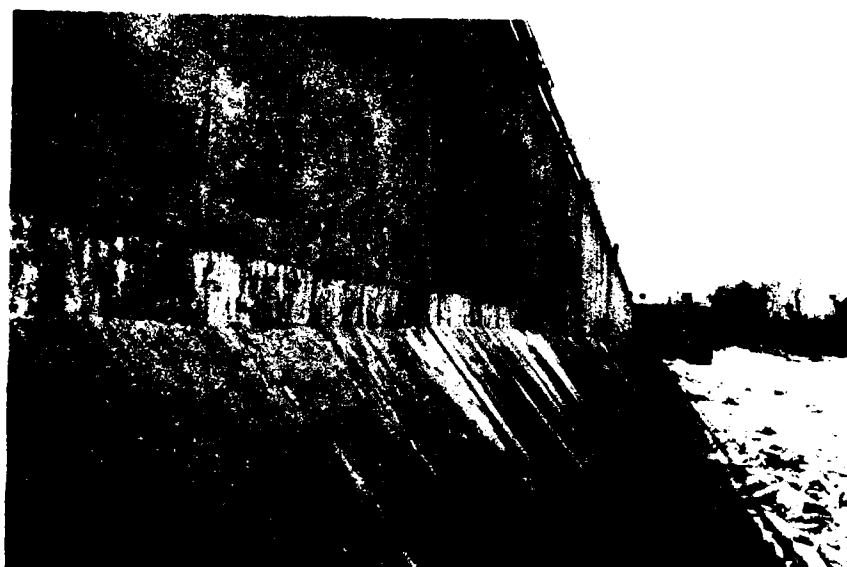
Figure 43. Typical condition of concrete overlay on back side of river wall, 1986, Dresden Island Lock

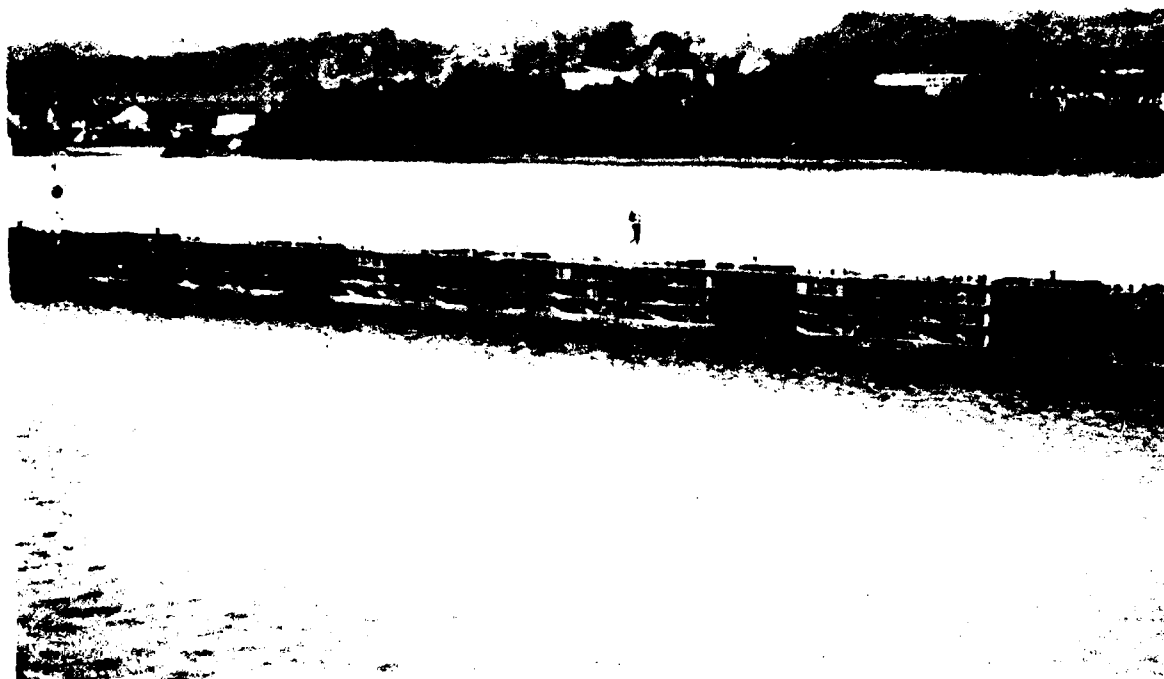
Figure 51. Upper guard wall extension, October 1977,
Lock No. 3, Monongahela River

total contract price of \$520,448. The contractor, Crain Brothers, Incorporated, had a lot of prior experience with cell construction and thus was instrumental in successfully completing the work on schedule. There was no settlement in any of the concrete caps, and the caps were free of cracks. The uppermost cell, which is concrete-filled, had a few hairline cracks in the top surface.

112. A steel fender system, consisting of four rows of TS 10 by 10 tubing filled with concrete, was constructed on the landside of the cells. The upper guard wall extension (Figure 51) was completed in September 1977 at a

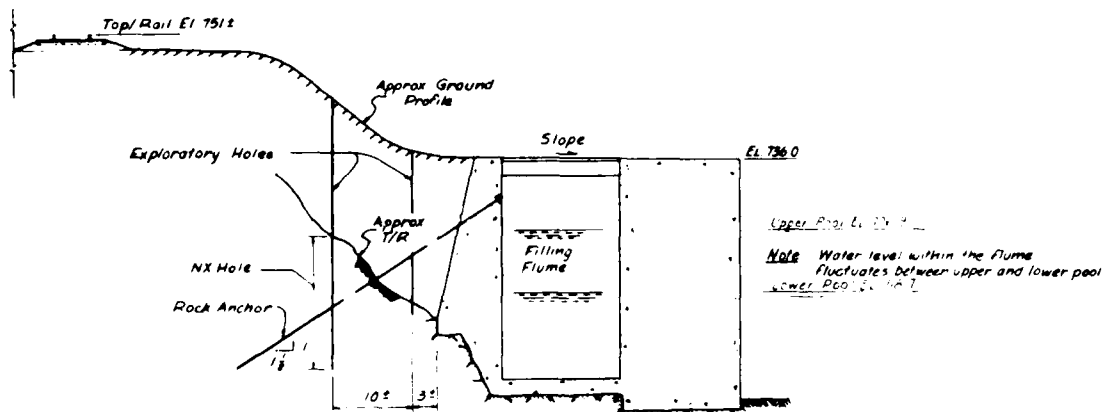
slabs and beams. The beams were crushed at both ends, and the deteriorated concrete in the beams exposed the reinforcing steel. There was evidence that some movement of the flume wall had occurred. With continued deterioration of the slab and beams, failure of the wall would have occurred.

Figure 52. Section through land chamber filling flume looking upstream, Lock No. 3, Monongahela River

114. It was determined that the best method of stabilizing the flume wall was with rock anchors (Figure 52). The original design called for the

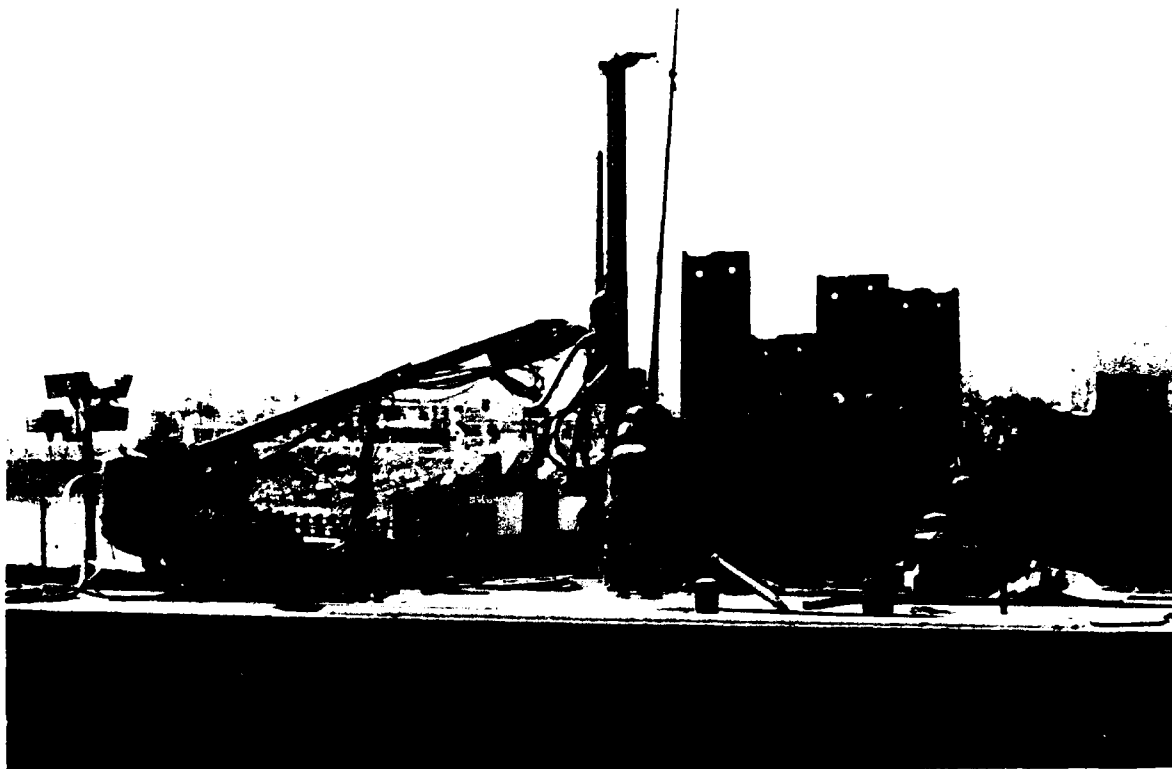
133. Shortly after beginning work on the middle wall anchors, ECI complained that the holes were caving and the anchor rods could not be installed. There were 15 middle wall anchors on the prime contractor's critical path. ECI claimed that increased progress could be achieved by pregrouting. In the interest of expediting the overall project, the Corps agreed to allow ECI to pregrout the first 15 holes, but stipulated an alternative solution should be found. The 15 anchors were installed (Figure 56), but with no improvement in the rate of work. The contractor continued to have drilling problems. At a meeting on 11 October 1978, the Corps directed ECI to install a 3-in.-diam casing in the 4-1/2-in.-diam hole prior to drilling the 2-1/4-in.-diam hole. The Corps had concluded that the material in the hole that the contractor claimed was from caving was actually the drill cuttings. The change in hole diameter from 2-1/4 to 4-1/2 in. was causing a pressure drop which allowed the cuttings to fall back into the hole. The drilling was being impaired by the cuttings. The 3-in. casing improved this condition, and there were fewer

Figure 56. Rock anchor installation, middle wall, September 1978,
Lock No. 3, Monongahela River

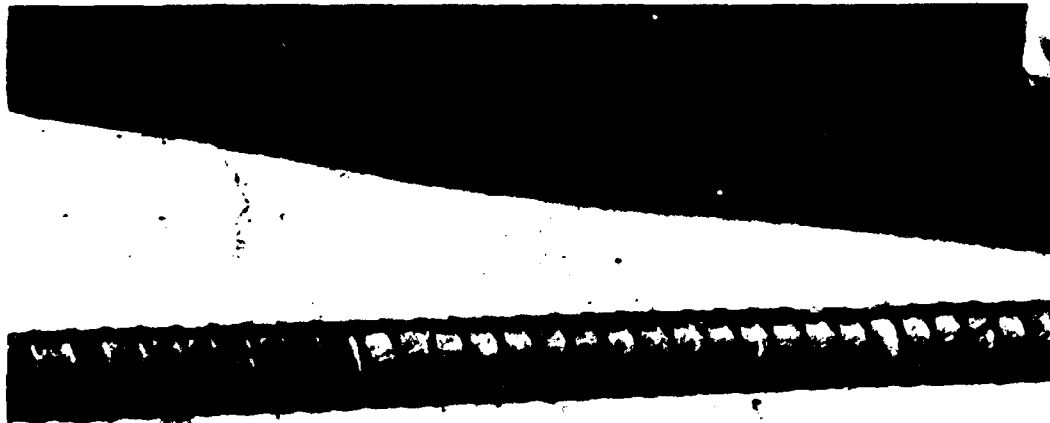
137. A failed anchor was removed from the middle wall and closely examined for any possible explanation of the failure. The general appearance of the bar in the anchorage zone indicated that the polyester resin grout had not bonded to the bar (Figure 57). The lower 5 ft had a light gray material lodged between the deformation of the bar that appeared to be resin grout (Figure 58). However, this resin was soft and pliable and could easily be removed from the bar. In other reaches of the bar, the resin was not soft,

Figure 57. Typical condition of anchorage zone of failed anchor, Lock No. 3, Monongahela River

138. In the interest of better consistency and progress in the anchor installation, the Corps recommended a cement grout system be used to anchor the bars. In March 1979, the contractor changed his procedures to drilling a 4-1/2-in.-diam hole full length and using cement grout. The anchors were tensioned after 9 days, and the stressing length was grouted. This method produced more consistent results and far fewer failures and thus was used to install approximately one-fourth of the anchors on the middle wall and three-fourths of the anchors on the river wall (Figure 60).

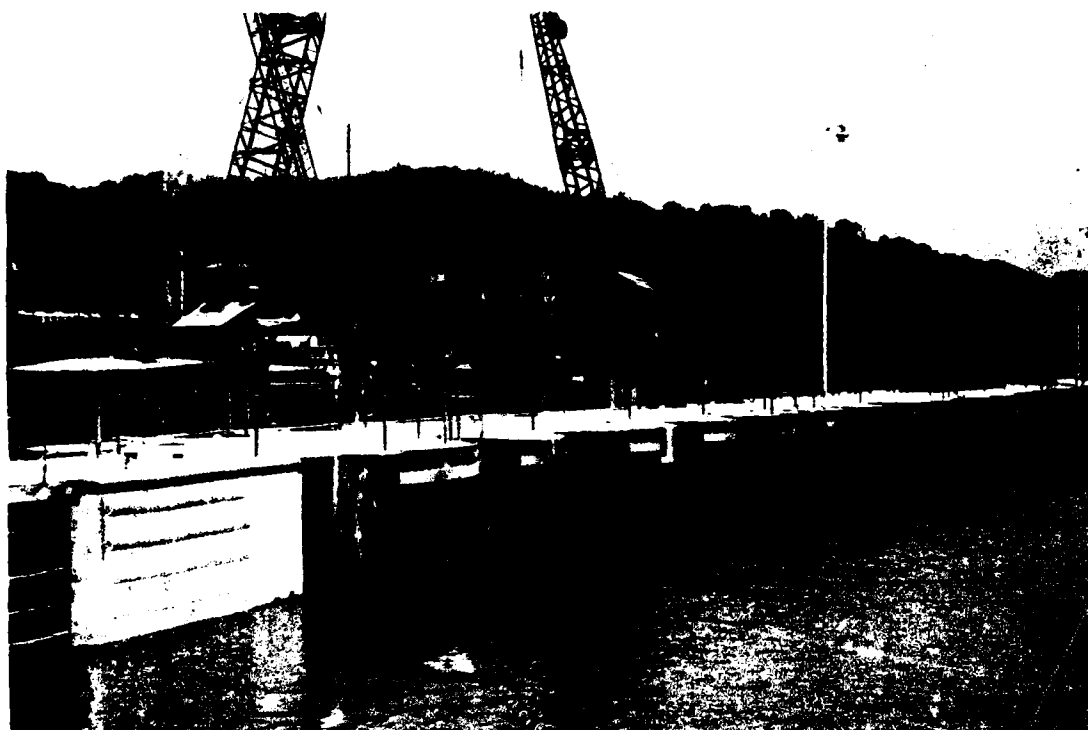
148. The river chamber extension was placed into operation in May 1980 (Figure 63). Initially, there was some concern about the sheet-pile cells

Figure 63. Completed river wall extension, May 1980,
Lock No. 3, Monongahela River

when the concrete caps on most of the cells and arcs settled to as much as 6 in. on the riverside. A diving inspection was conducted to determine whether cell fill was being lost because of parted interlocks or erosion below piling. The divers found neither condition, and it was concluded that the settlement was caused by fill compaction and would cease.

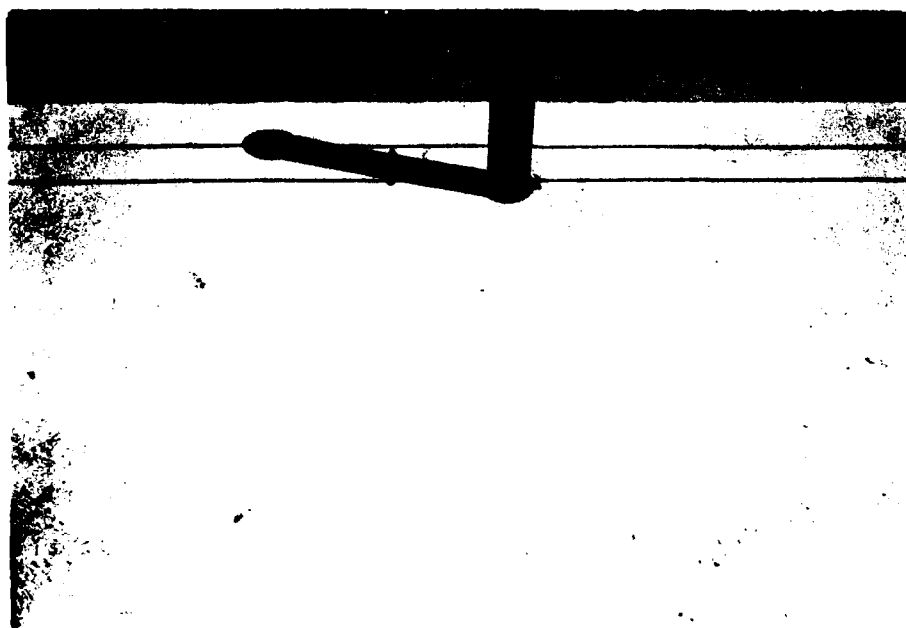
170. In June 1982, isolated cracks were observed in the top surfaces of the lock walls (Figure 75). Most of the cracks are perpendicular to the face of the lock chamber. Although a few cracks were located on approximately 5-ft centers, the regularity noted at other projects was not observed. Rather, the cracks tend to start and terminate at reentrant angles and at joints in the corner protection armor. The thin polymer mortar overlay was debonded and buckled in several places (Figure 76). Failure of the shotcrete overlay appeared to be progressing (Figure 77).

Figure 75. Typical cracks in tops of lock walls, June 1982,
Lock No. 3, Monongahela River

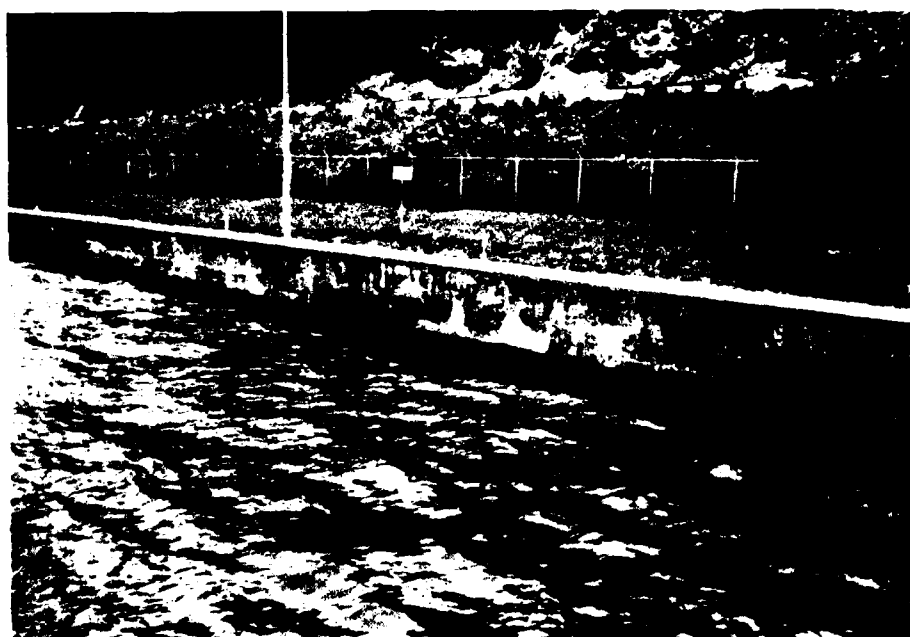
Figure 77. Typical spalling and abrasion of the shotcrete resurfacing on the lower guide wall, June 1982, Lock No. 3, Monongahela River

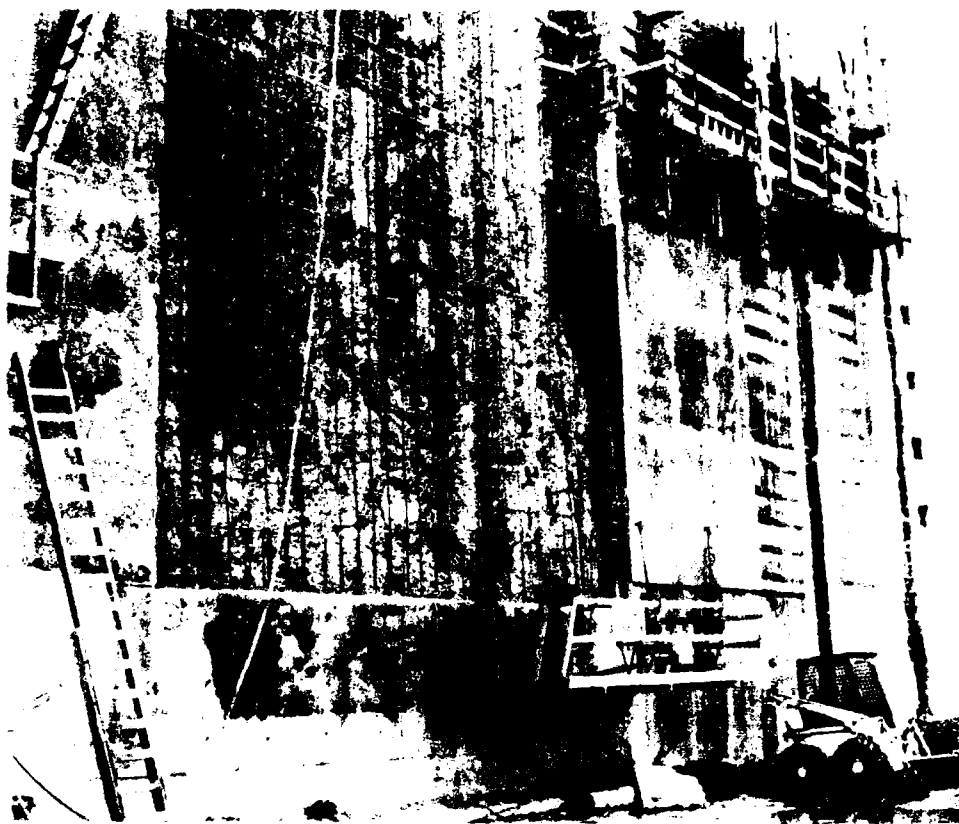
202. During May 1980, a trial lock wall resurfacing was conducted on monolith L-5. Prior to resurfacing, existing concrete was removed from the chamber face to an average depth of 18-in. Reinforcing consisted of No. 6 bars on 12-in. centers each way anchored with No. 8 dowels 3 ft on centers (Figure 86). The dowels were embedded 18 in. into the existing concrete with polyester resin cartridges. The area to be resurfaced was formed and placed in two lifts 23 ft high and 30 ft wide. A 3/4-in. thick plywood faced form

Figure 86. Trial resurfacing monolith L-5 prior to forming (left) and tainter valve monolith L-4 reconstruction, 9 May 1980, Lock No. 1, Mississippi River

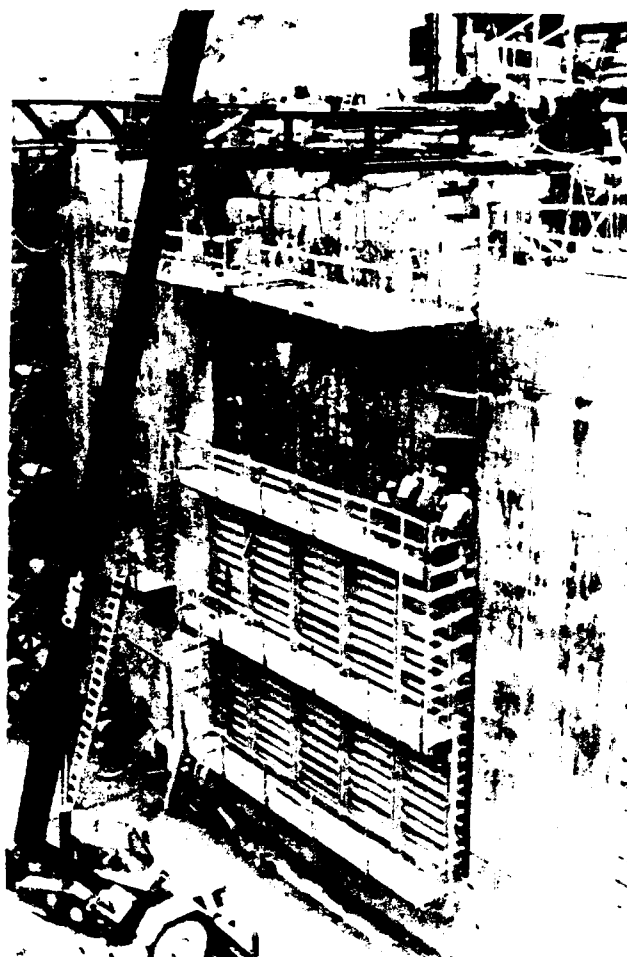
was used for both lifts. The single section form (Figure 87) with structural aluminum bracing was held in position with 1-1/4-in.-diam anchor bolts spaced 6 ft on centers. The anchor bolts were embedded 24 in. into the existing concrete with polyester resin cartridges. The existing concrete was washed with a water blaster (7,000-psi pressure) the evening before each placement.

Figure 87. Form work in place for Lift A of trial resurfacing, 12 May 1980, Lock No. 1, Mississippi River
